**THAMES RIVER BASIN  
NORWICH, CONNECTICUT**

**GREENVILLE DAM  
CT. 00206**

**PHASE 1 INSPECTION REPORT  
NATIONAL DAM INSPECTION PROGRAM**

**OCTOBER, 1980**

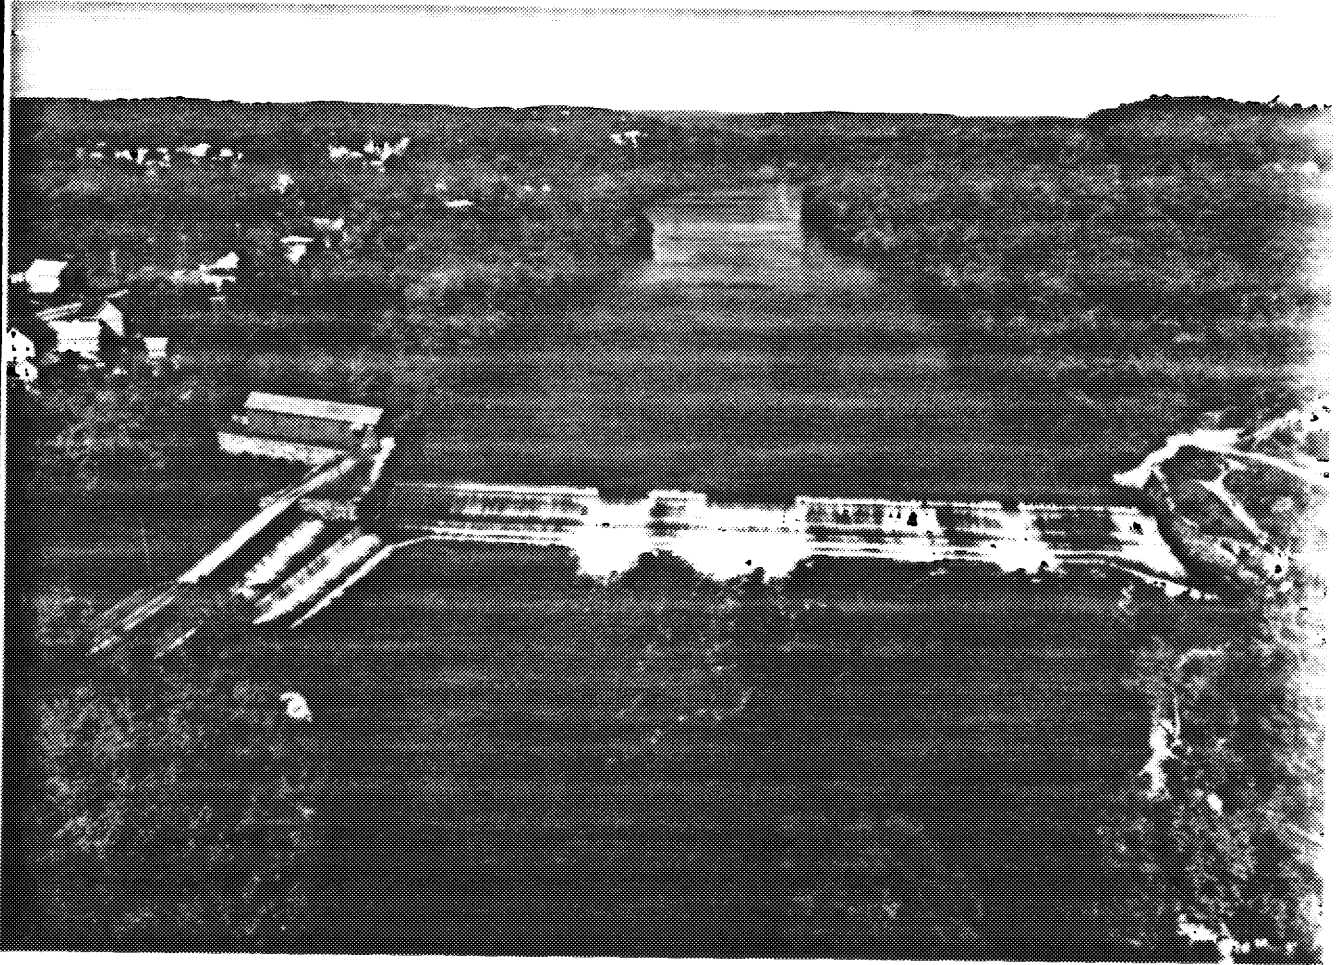
OVERVIEW PHOTO - Greenville Dam

1. Outlet Works and Right Embankment. The outlet works and right embankment form a continuous structure at the right end of the spillway. This complex is shown in the overview photo. The downstream side end of the outlet works structure is shown in Photo C-10 and the intake side in Photo C-2. The stone masonry forming this structure appeared to be in fair condition with missing mortar in many areas and trees and vines growing out of the base of the wall. The right abutment of this structure is shown in Photo C-6.

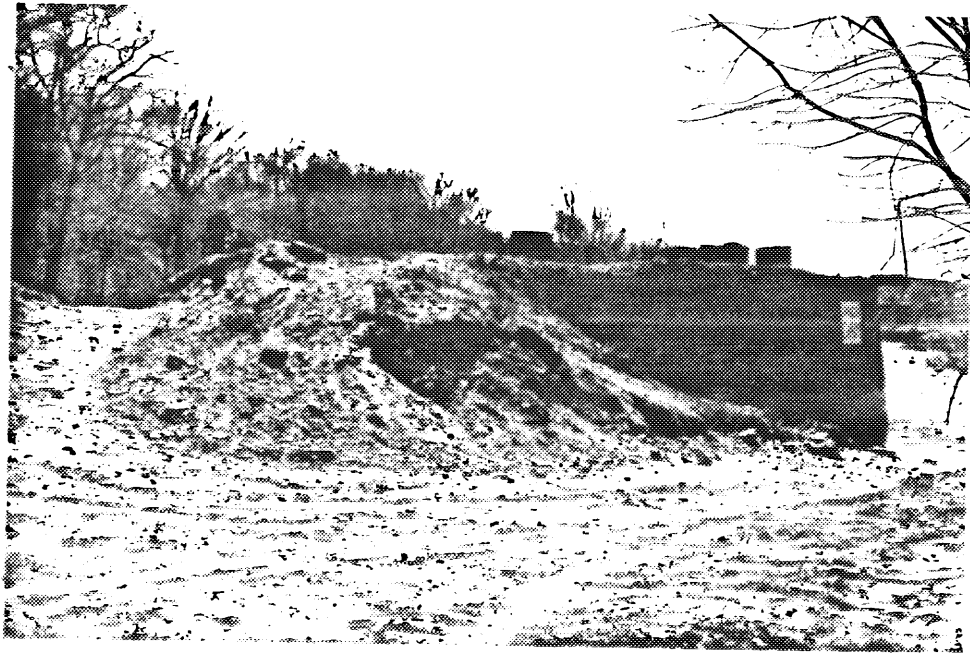
2. Left Embankment. The left masonry block wall of the dam is shown in Photos C-1 and C-5. A concrete training wall has been built downstream from the masonry wall to divert water away from the toe of the downstream masonry wall and adjacent earth embankment (Photos C-5 and C-7). A roadway has been excavated adjacent to the left abutment as indicated in Photos C-1 and C-4. This roadway construction has created a minor depression in the crest profile of the dam. The length and depth of this depression could not be measured and inspected due to overflow conditions. A small seep was noted near the downstream toe of the embankment approximately 30 ft. to the left of the end of the masonry training wall. This seepage zone can be observed in Photo C-13. The Owner reports that repair work is presently taking place at the toe of the left embankment where a small tributary flows into the

PHOTO C-1 Upstream face of dam , left embankment.

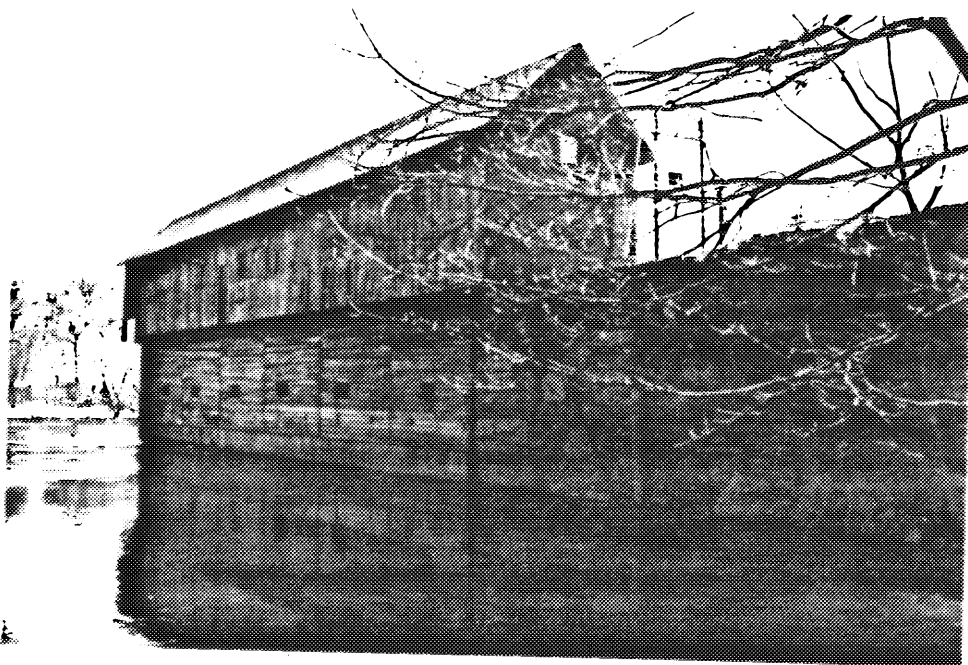
2. Gatehouse and Gate Controls. The gatehouse is a timber superstructure on the stone masonry portion of the embankment. This structure is shown in Photos C-2, C-10, and C-12. The general condition of the superstructure was to be judged fair. The gates appeared to be well maintained and in operating condition although an operational check was not conducted. Three of the six gates can be electrically operated, the remaining gates are manually operated.

PHOTO C-2 Upstream face of dam, right embankment.

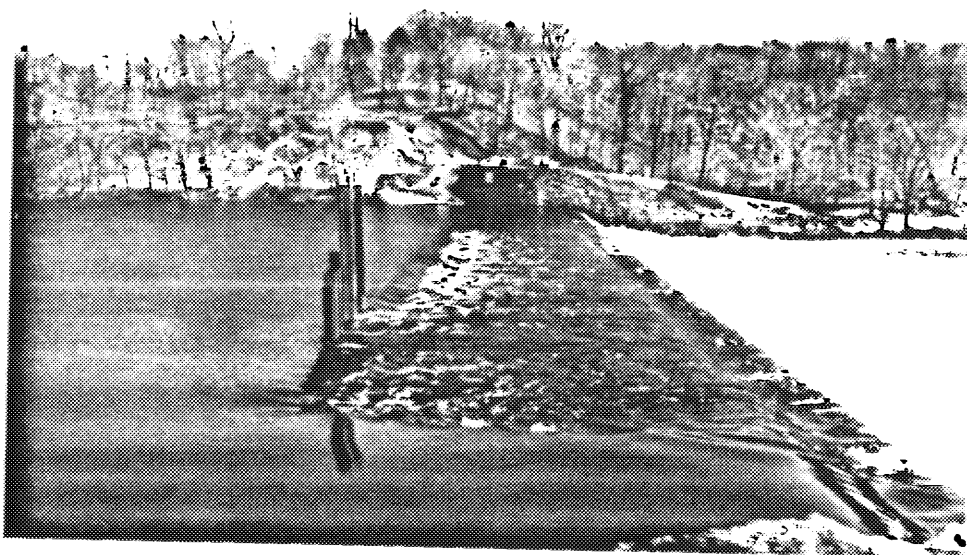
- a. General. Trees and brush growing on the embankments are generally trimmed side cut on an annual basis. Maintenance was in progress on a portion of the spillway as can be seen in the Photo C-3. Except for some vegetation growing from the masonry of the embankment the facilities appeared to be well maintained.
- b. Operating Facilities. All of the gates receive as needed maintenance to keep them operable. At the time of the inspection, 3 of the gates had recently been overhauled. One gate had been replaced in its entirety, two others, partially replaced.

PHOTO C-3 Crest of spillway from right dam embankment.

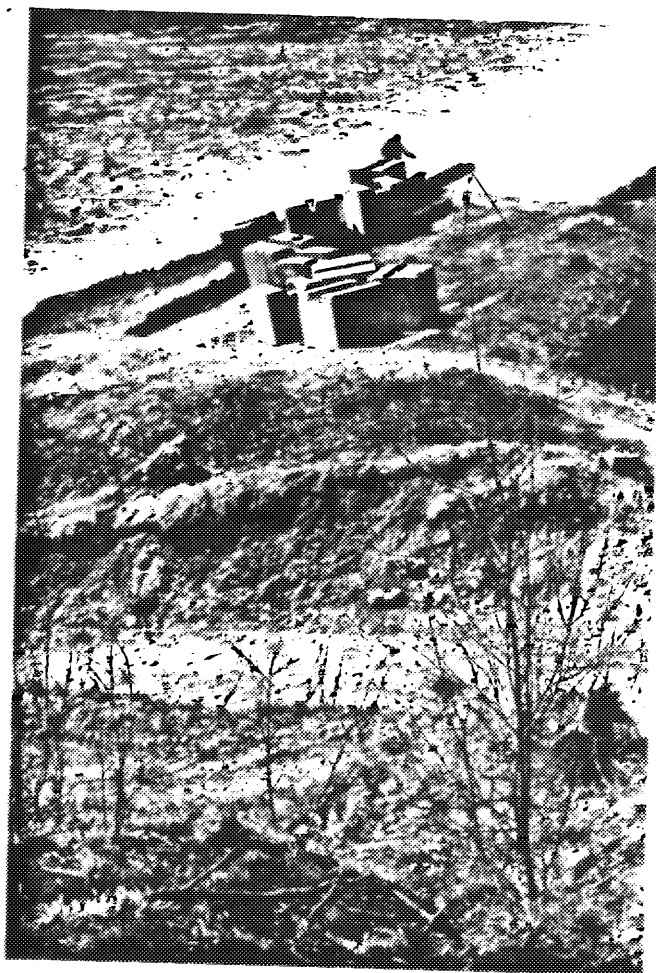
PHOTO C-4 Crest of dam embankment, left side.

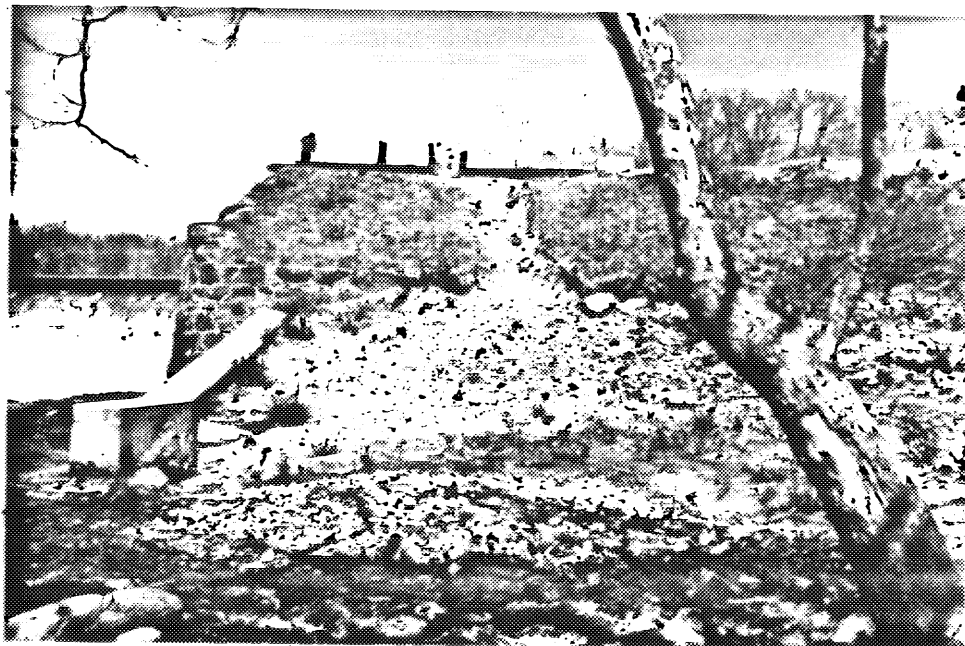
PHOTO C-5 Downstream face of embankment left side.

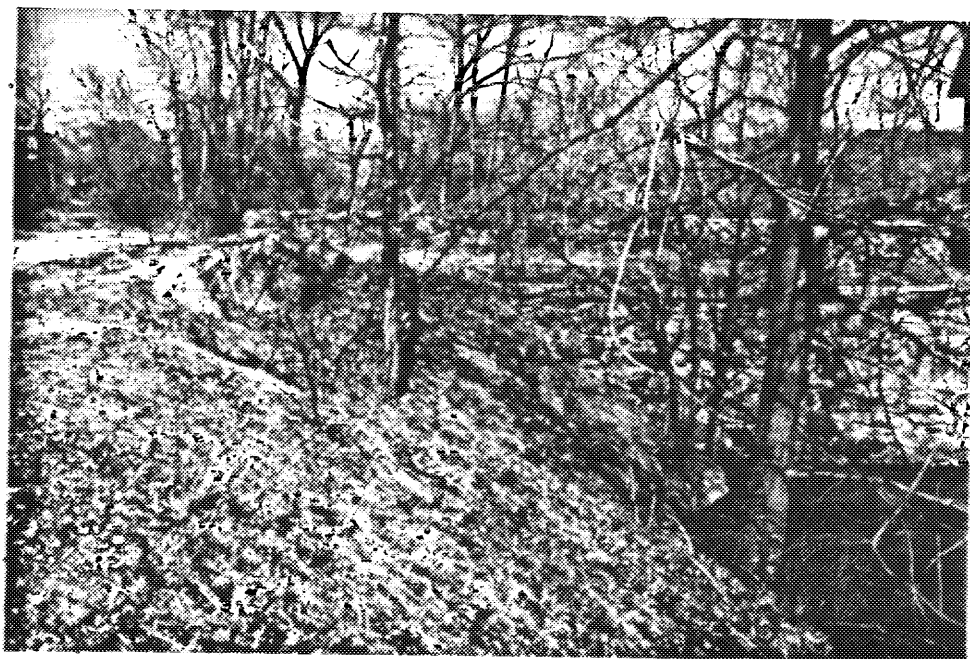
PHOTO C-6 Downstream face of dam (masonry) at right abutment,

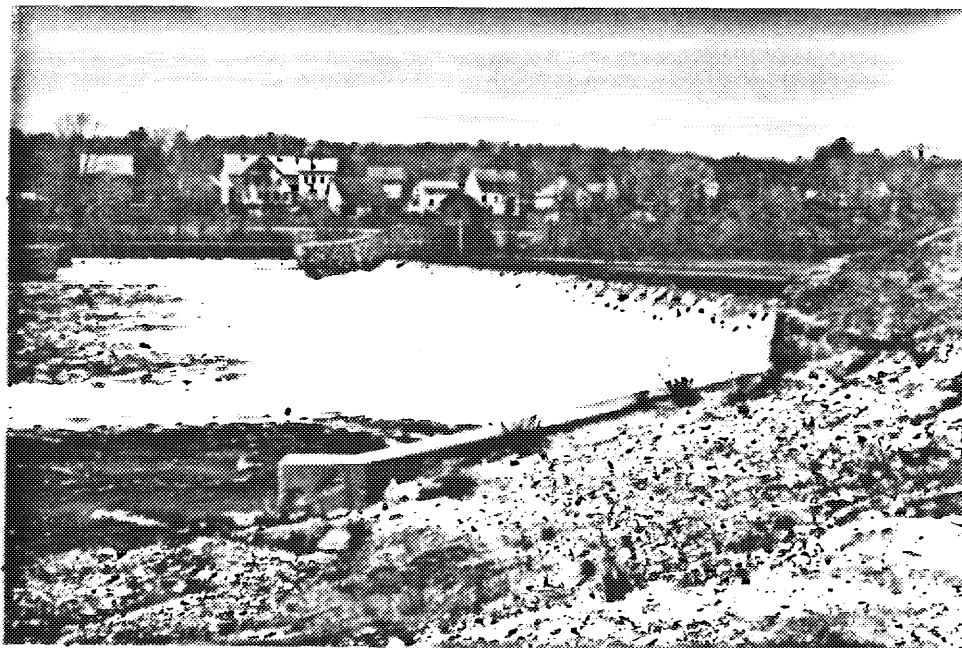
PHOTO C-7 Spillway from left side.

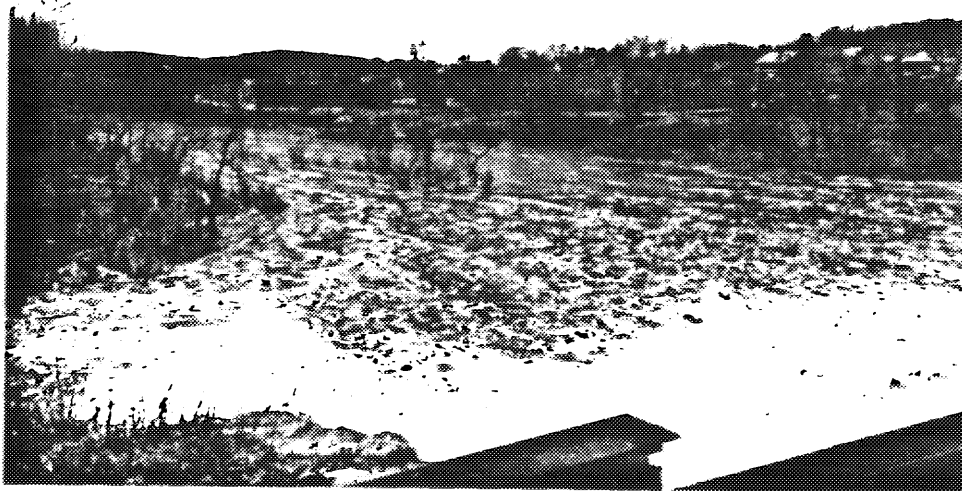
- d. Reservoir Area. No specific detrimental features were observed in the reservoir during the visual inspection. The slopes of the shoreline are overgrown with trees and brush. Because of the dense vegetation, periodic observations should be made to check for debris such as tree trunks and limbs which could become entrapped on the spillway crest or outlet gates.
- e. Downstream Channel. The downstream channel is the natural riverbed of the Shetucket River. No significant obstructions existed in the channel at the time of inspection (See Photo C-8).

PHOTO C-8 Spillway discharge channel (Shetucket River)  
from left embankment.

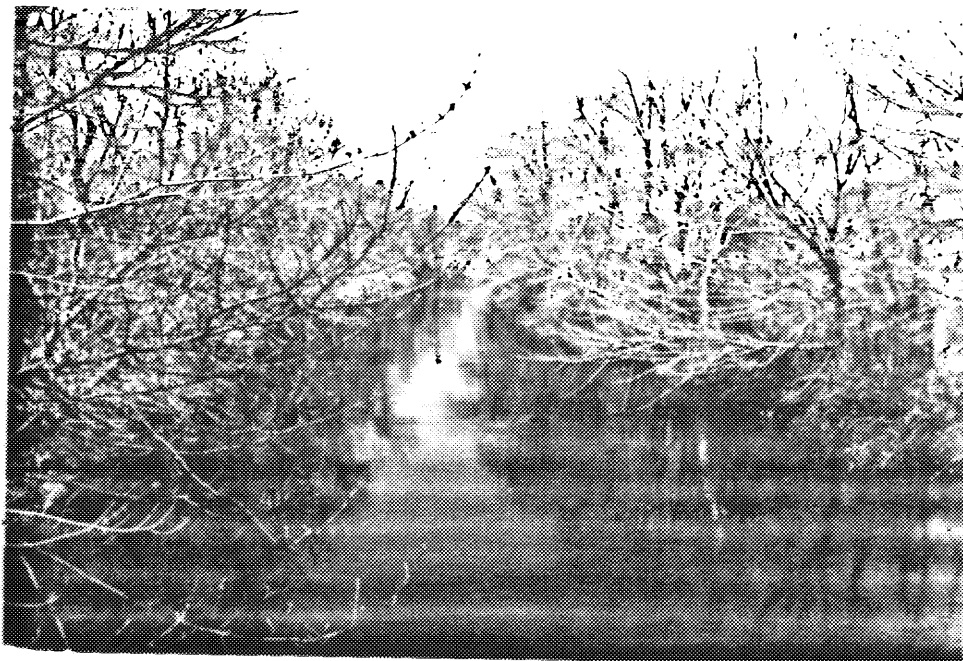
3. Canal Outlet Channel Spillway. This structure is shown in Photo C-12. The structure is of concrete and judged to be good condition.
4. Canal Intake Channel. The intake channel is shown in Photo C-9. The channel runs parallel to the Shetucket River and is connected with the river immediately upstream from the gatehouse (Photo C-2). The location of the intake channel is visible in the overview photo as a break in the trees upstream from the gatehouse. There are many overhanging trees and branches.

PHOTO C-9 Intake channel.

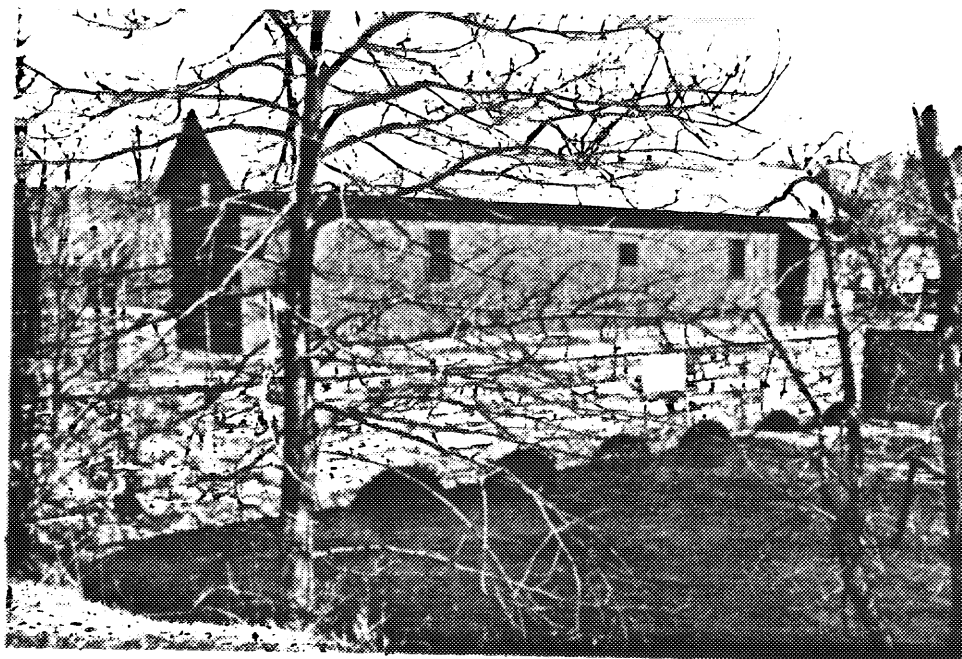
PHOTO C-10 Outlet works.

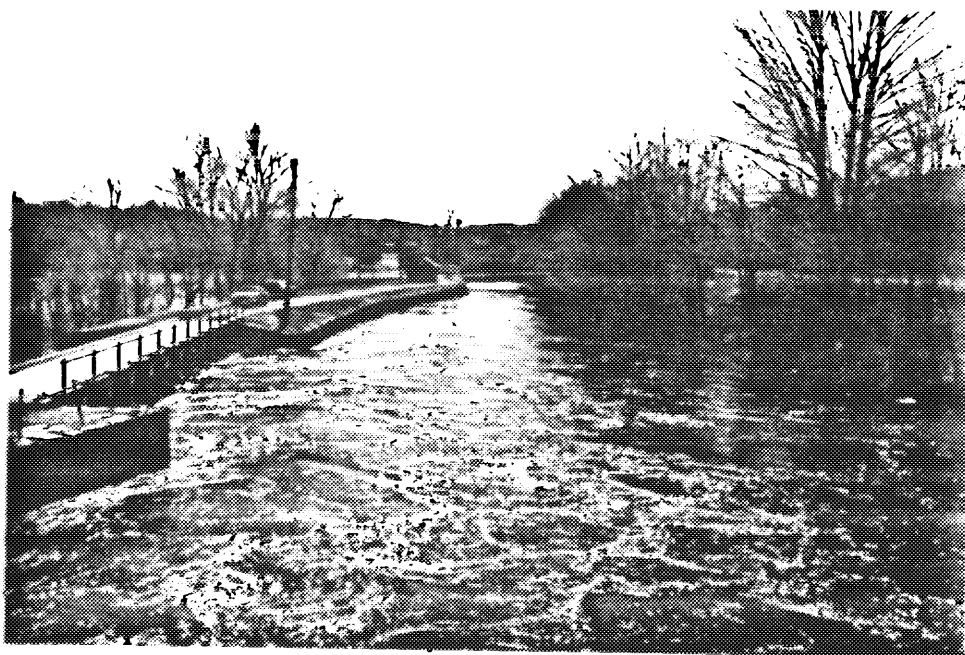
PHOTO C-11 Outlet channel.

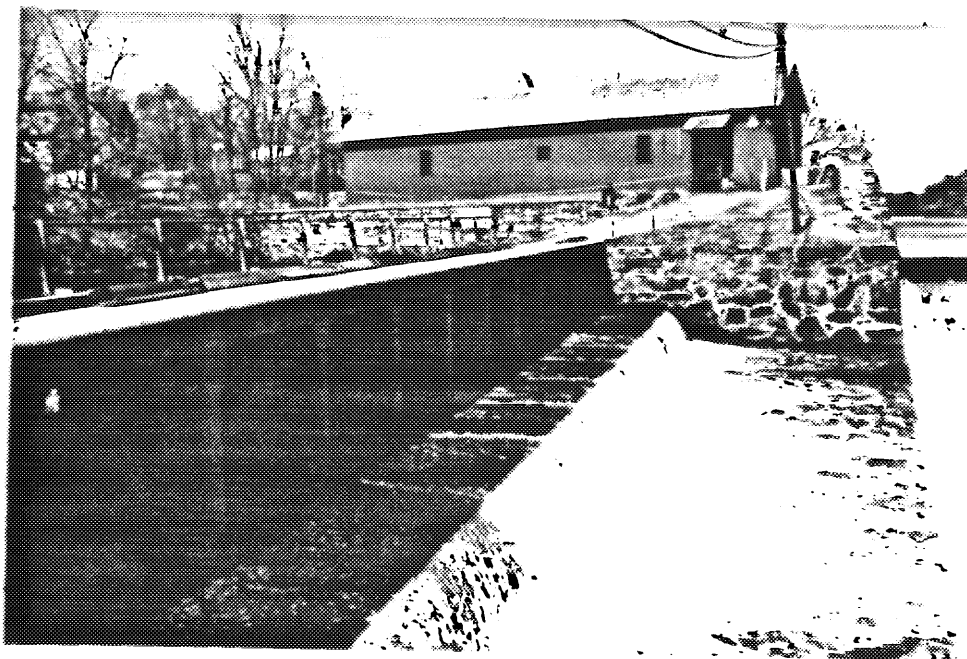
PHOTO C-12 Outlet channel spillway discharging to  
Shetucket River.

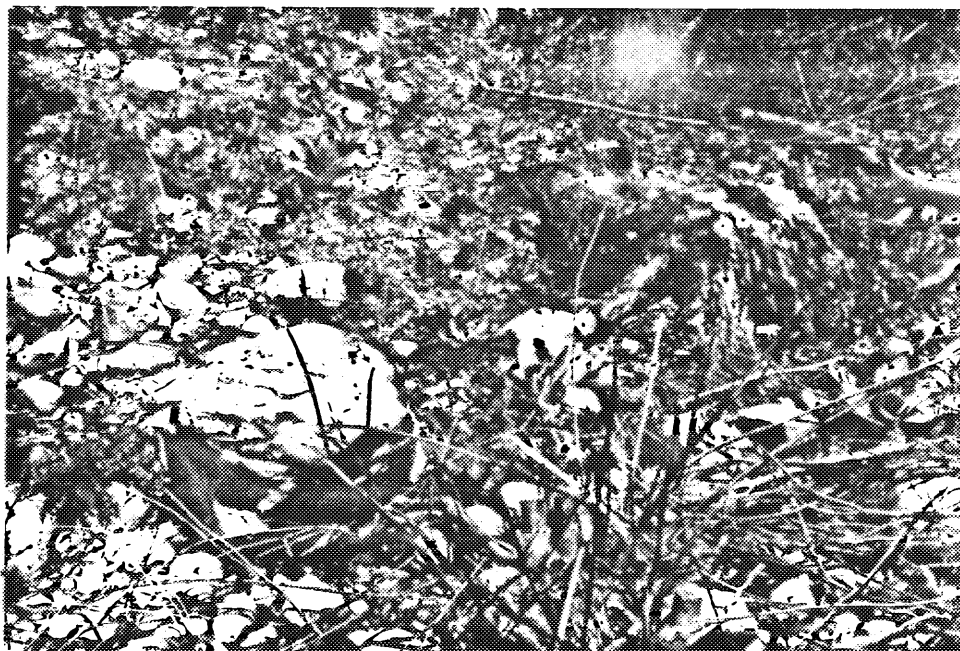
AREA EVALUATED	CONDITION
<u>DAM EMBANKMENT</u>	Timber crib spillway section. Earth sections at the abutments.
Crest Elevation	20.3
Current Pool Elevation	21.8
Maximum Impoundment to Date	Unknown
Surface Cracks	None observed.
Pavement Condition	Undulation along right side, left side covered with steel beams and concrete block.
Movement or Settlement of Crest	
Lateral Movement	None observed.
Vertical Alignment	Good
Horizontal Alignment	Good
Condition at Abutment and at Concrete Structures	Right abutment good. A road has been cut into the left abutment.
Indications of Movement of Structural Items on Slopes	None observed.
Trespassing on Slopes	Roadway and worn path on left side of dam. Erosion has occurred at the downstream toe.
Sloughing or Erosion of Slopes or Abutments	
Rock Slope Protection	None
Unusual Movement or Cracking at or Near Toe	None observed.
Unusual Embankment or Downstream Seepage	Small seepage area observed along the downstream toe on left side of the dam.

PHOTO C-13 Seepage area, left embankment.

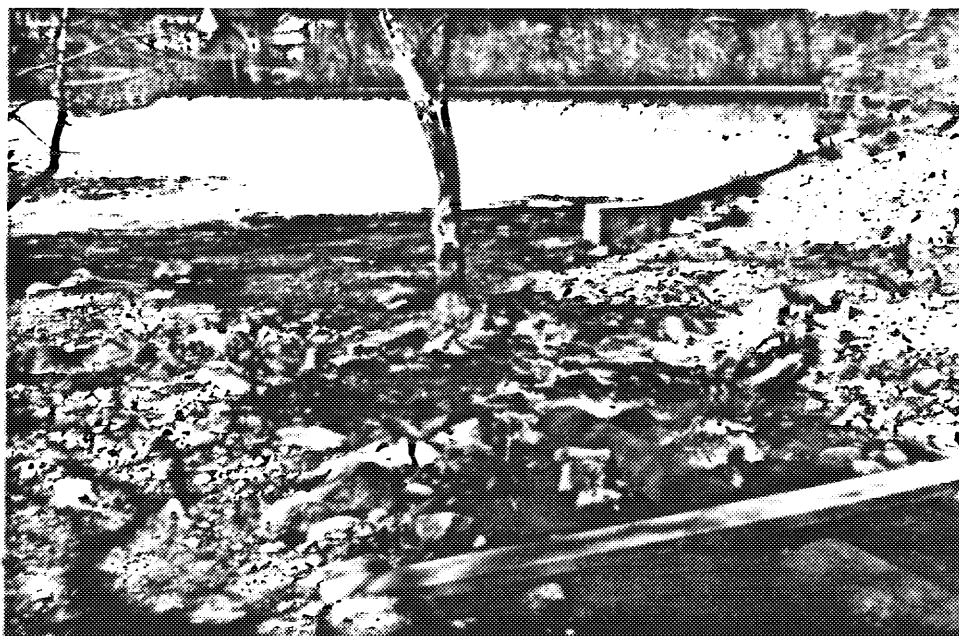
Shetucket River just downstream from the spillway (See Photo C-14). This repair includes the installation of a pipe and headwall to carry the tributary flows more readily into the main river.

PHOTO C-14 Erosion area downstream of left embankment.
